Inspection Report

Minerals Regulatory Program

Mine Name: Bartons Peak
Operator Name: Martinique Mining

Permit number: M0170045
Inspection Date: August 28, 2006
Time: 3:40-4:30 PM

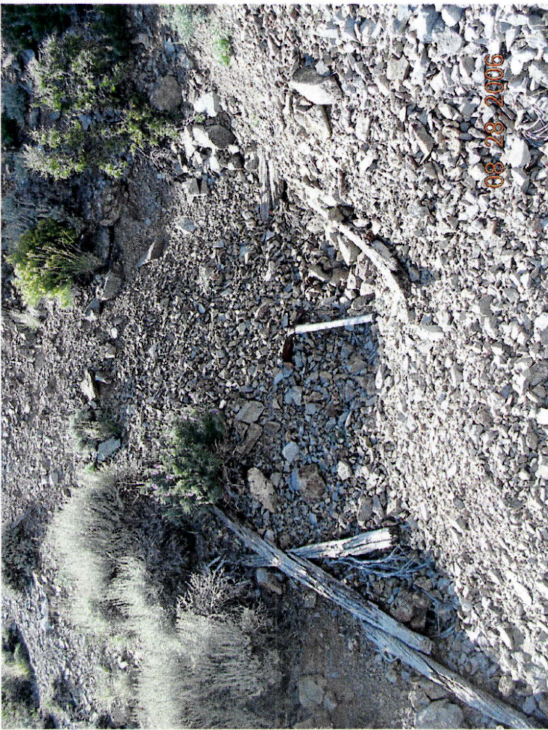
Photo 1. This is the site of one of the mine openings. Note the old pick.

There were five openings that have now been closed, but, according to Mr. Rakow, only four of these were opened by the operator. Some of the openings date back 100 years. I do not know how they were closed or how far any workings extend. The workings could not be terribly large just because the mountain is not very large.

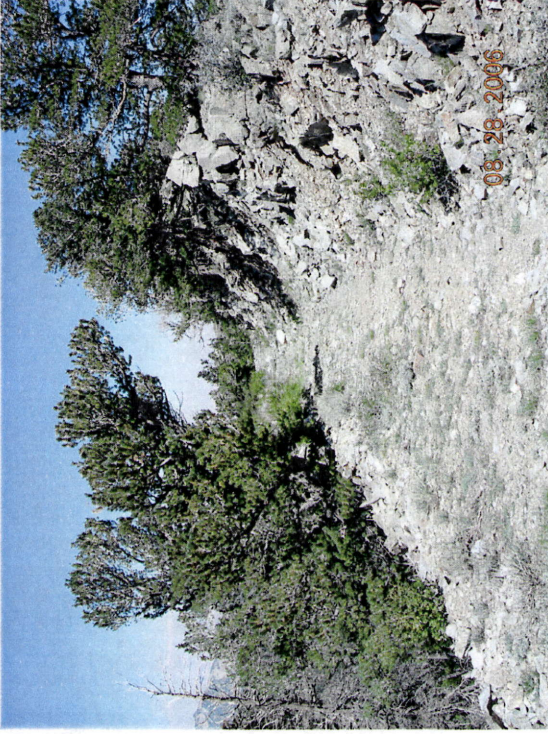
Photo 3. The remains of the road leading to the mine.

There is an old road leading most of the way to the site, but it is overgrown and not driveable. There is no road or even a trail for the last few hundred yards to the portals. It is a difficult hike traversing a steep hillside with a lot of loose rock.

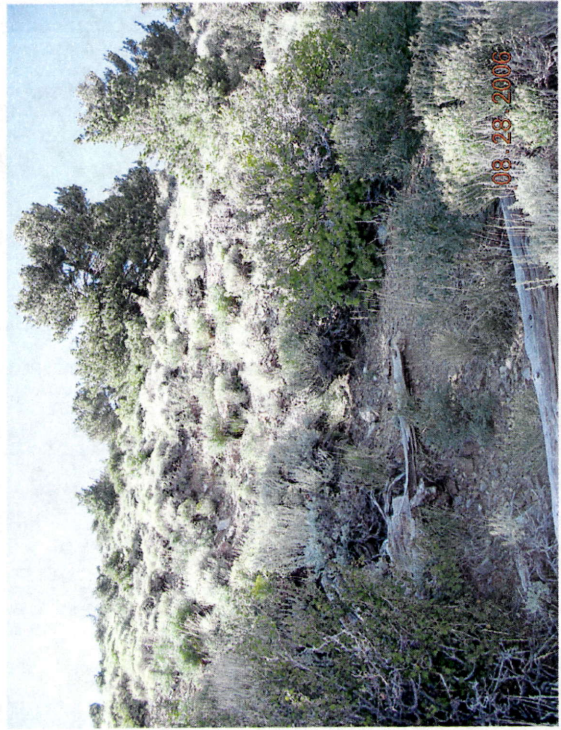
Photo 2. This was another mine opening.

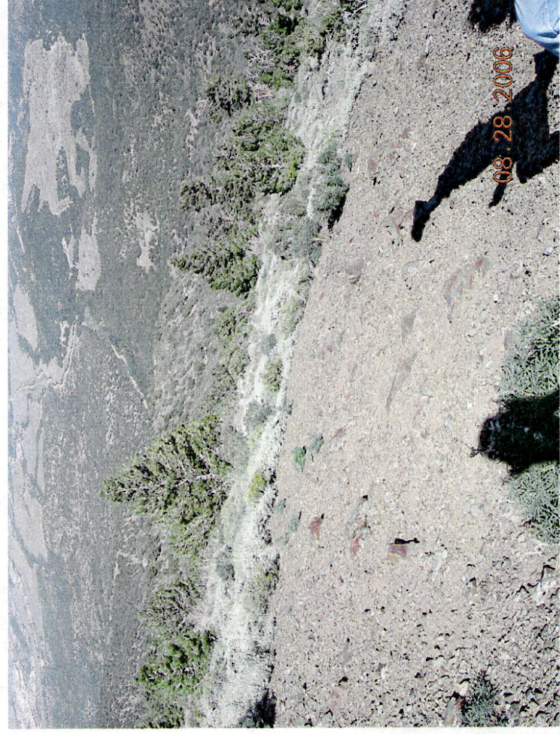
Some vegetation has encroached into the mine dump and portal areas, and while the amount of vegetation is limited, these areas blend reasonably well with surrounding areas (Photo 4). Vegetation cover on the road is similar to adjacent areas, but I did not take cover measurements.

Photo 4. This is probably the largest of the mine dumps.

I will recommend that the Division release this site based on the reclamation that has been done and based on the fact that only hand equipment was used in the mining operation.
